# Manhole Inspection Summary

Manhole # S43A\_\_008MH

**Location** Address: **Broadway**

Cross Street: **Orleans St**

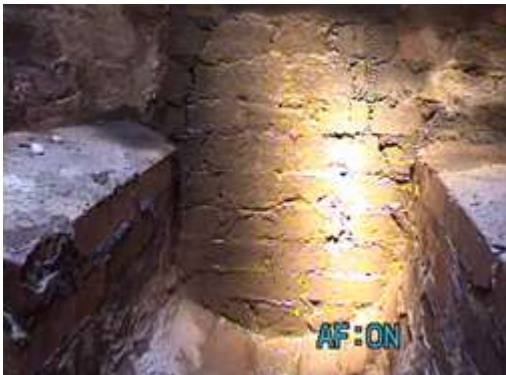
capped at the 6 oclock

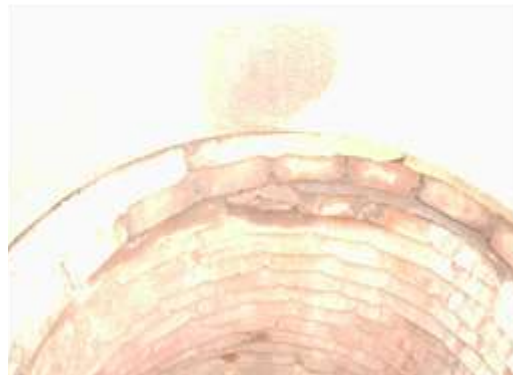
Defect 2

Condition: ☐ Sound ☐ Cracked ☐ Root Intrusion ☒ **Loose Brick** ☐ Deteriorated

Infiltration: ☐ None ☐ Joint ☐ Cracks ☐ Mortar ☐ Roots ☒ **Wall**

Loose Bricks

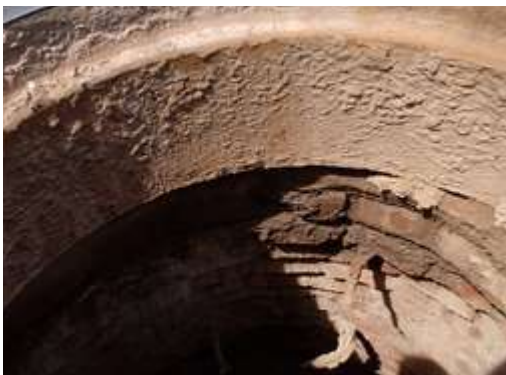
Defect 1

Offset: **2** (in.)

☒ **Leaks**

Frame Leaks, Offset Frame

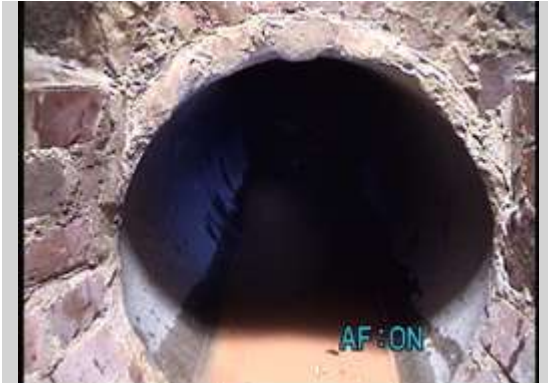
12 O'Clock Outflow

15 in. Circular Gravity Sewer  
Pipe Out @ 12 O'Clock

Pipe Height: **15.6** (in.) Rod and Bar (Angled)  
Pipe Material: **Clay** ☐ Pipe Lined  
Invert Depth: **9.90** (ft.) Flow Characteristics: **None**  
Deposits: ☒ None ☐ Mud ☐ Sludge ☐ Debris ☐ Grease  
Silt Depth: (in.) Deposits Extent:  
Infiltration: **None** Pipe Seal Cond: **Sound**

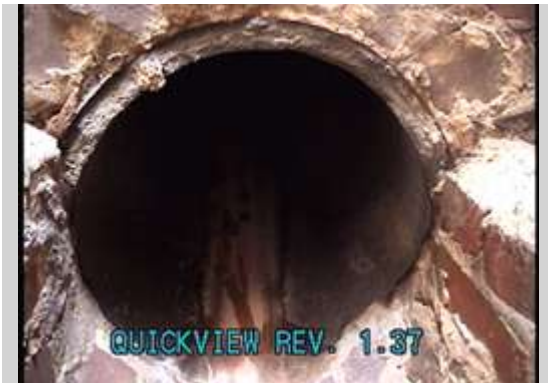
3 O'Clock Inflow

12 in. Circular Gravity Sewer  
Pipe In @ 3 O'Clock

Pipe Height: **12** (in.) Rod and Bar (Angled)  
Pipe Material: **Clay** ☐ Pipe Lined  
Invert Depth: **8.90** (ft.) Flow Characteristics: **None**  
Deposits: ☒ None ☐ Mud ☐ Sludge ☐ Debris ☐ Grease  
Silt Depth: (in.) Deposits Extent:  
Infiltration: **None** Pipe Seal Cond: **Sound**

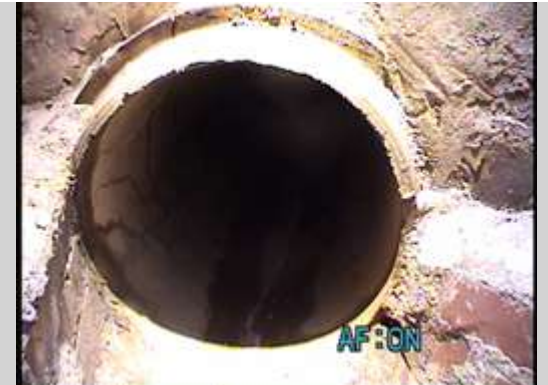
9 O'Clock Inflow

10 in. Circular Gravity Sewer

Pipe In @ 9 O'Clock

Pipe Height: **10.8** (in.) Rod and Bar (Angled)

Infiltration: **None** Pipe Seal Cond: **Sound**
